## Shingwedzi Camp – Access for Guests with Mobility Challenges

### Shingwedzi Camp – Nxanatseni Region, Far Northern Kruger National Park

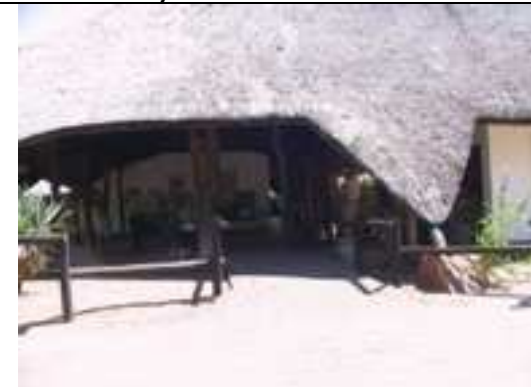
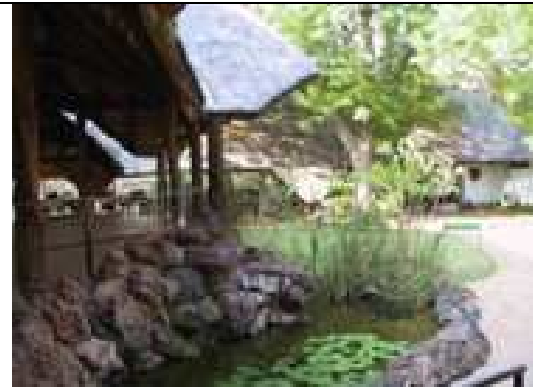
The camp's main complex also has adequate open-plan parking and the entire complex is ramped throughout to provide easy access to reception, shop, restaurant and tables overlooking the adjacent river. There are accessible ablutions in the men's and ladies ablutions

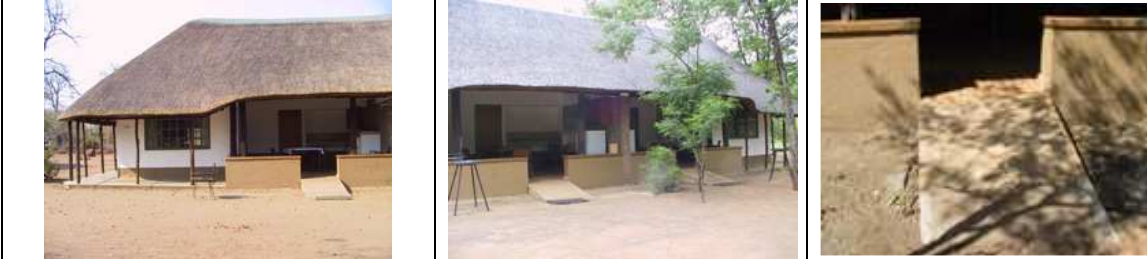
**Accessible Accommodation:** Of the 82 accommodation units in the camp, 4 are marked as accessible units (A1, A2, A15, & A16) with the type bungalow and code BD5Z, meaning they each have 5 beds. These 4 units however have baths with grab rails and do not have roll-in showers, which is not ideal and should be changed. The ramps into these units are also steeper than what is prescribed and many wheelchair users will need assistance to use them.
