## Tamboti Tented Camp – Access for Guests with Mobility Challenges

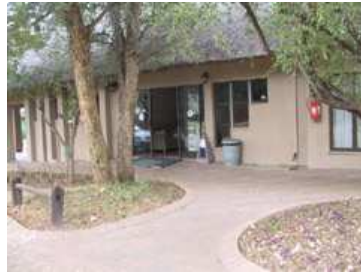
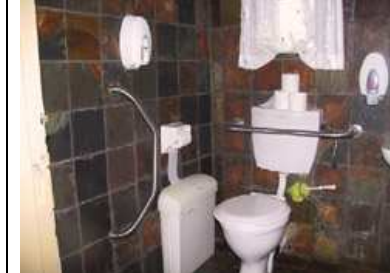
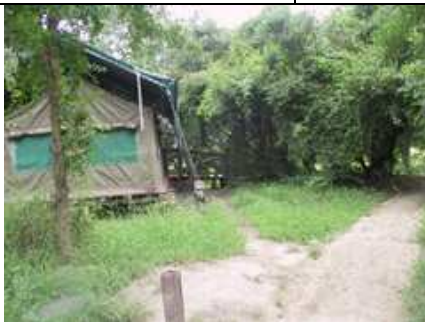
Visitors with reserved accommodation in Tamboti must first check in at the reception at Orpen Camp. Here there is a ramped entrance and a wheelchair ablution (where the grab rail on the adjacent wall needs repositioned!).

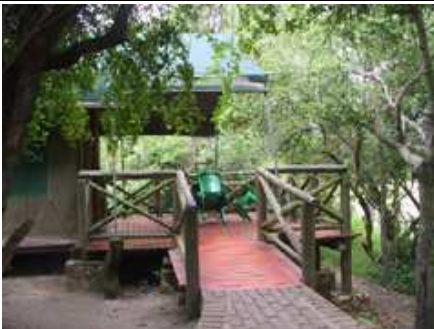
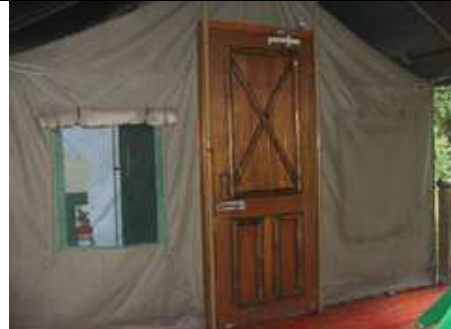
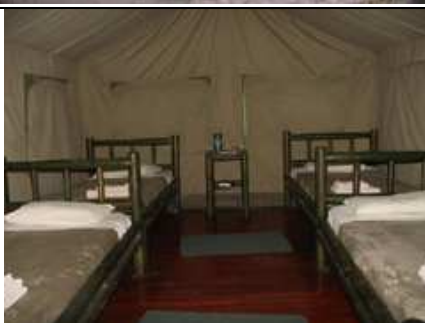
The 2 **accessible tents with communal ablutions** are identical except that one has 4 beds and the other only 2. There is a bit of soft sand to negotiate from the parking area in front of these units, but then the path is wide and bricked, while the access to the units' decks are ramped.

Although the beds are quite low in these units, there is plenty of space for manoeuvring inside of the tents.

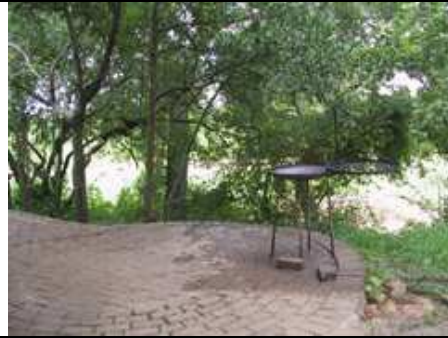
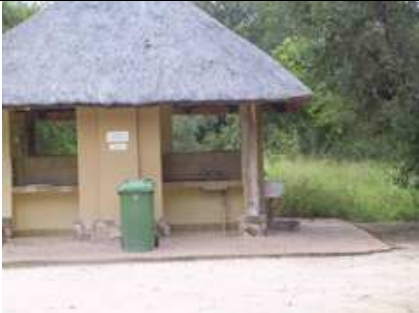
Each unit has its own braai (barbecue) facility for cooking on an open fire. The ones in the accessible units have been made accessible from all sides

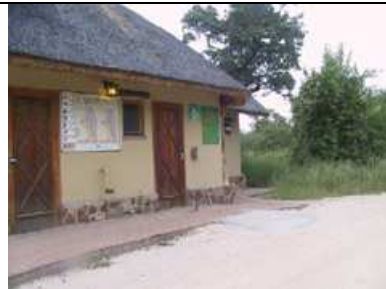
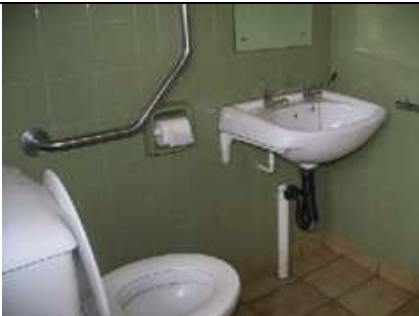
The communal washing up facility (with hot-plates for cooking) is located about 20m from the accessible units. There is a small step (about 5cm from the ground up to the paved area) caused by rainfall erosion, but most wheelchair users should be able to negotiate this with ease.

The communal ablution block where the wheelchair accessible toilet and shower is located is perhaps 30m from the units. The earth has been built up to the paved level where the heavy summer rains had created a step.

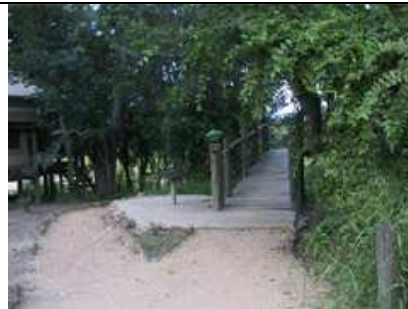
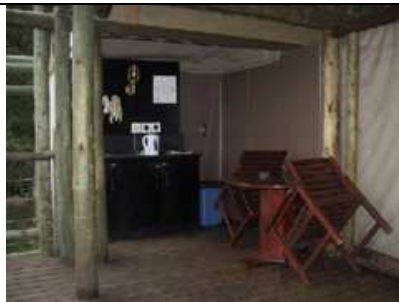
The ramp from the parking area is not too steep and the gravel from the parking to the ramp is compact, making mobility in a wheelchair easy. Heavy rain has meant a slight step from the gravel up to the concrete base of the unit. The braai (barbecue) facility is at the base of the ramp to the left of the image.

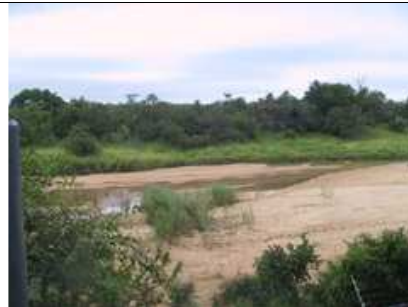
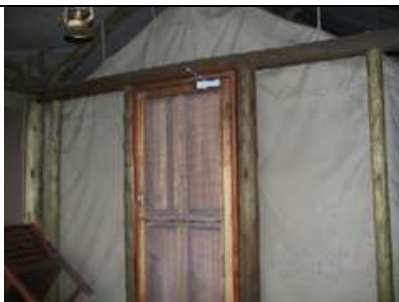
The unit's deck has a open plan kitchen and table all of which is easily accessible to a wheelchair user.

The deck also provides excellent views of the adjacent riverbed which hosts a steady stream of game that can be viewed from the comfort of the unit.

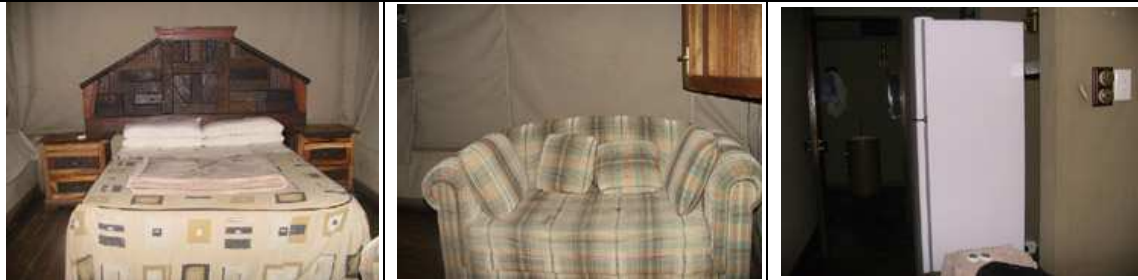
The door to the interior (left) is spring loaded to help keep out the monkeys and baboons. It is however wide enough for wheelchair passage. Inside the unit is less spacious than the communal tents. There is one double bed, with bedside cabinets and just enough space for a wheelchair to pass between the side of the bed and the wall of the tent. Much of the bedroom interior space is taken by the sleeper couch. (see below)

Baboons have proved to be a big problem at Tamboti and as a result all fridges are kept indoors and the units are provided with keys and locks. This creates a space issue as it is positioned in the passage from the bedroom to the bathroom. However there is just enough space to get past in a wheelchair to get to the bathroom (see above right)

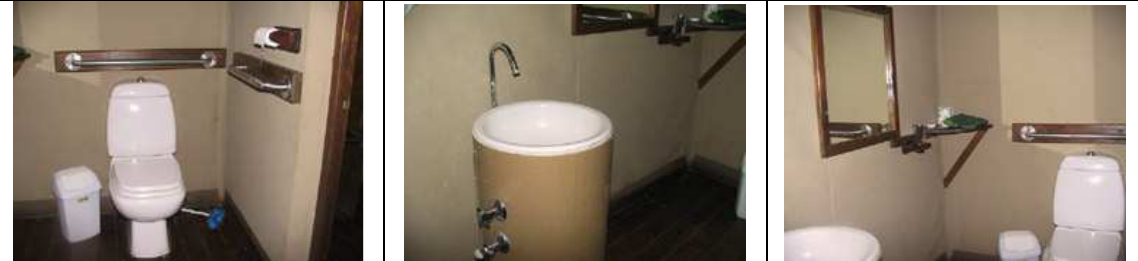
The unit's ablutions are not well designed and there are several factors that are not in keeping with a properly accessible unit. The toilet itself is fine and is equipped with grab rails adjacent and behind the toilet, but the water basin is out of reach of a person sitting on the unit. The design of the basin is also not suited for a person in a wheelchair as they cannot position their chair underneath the basin. Also the taps are not suitable for persons with a cervical injury with limited hand control as there are standard turn taps. The taps are also positioned in a very awkward position for a person in a wheelchair. Then the position of the basin is in an awkward position in relation to the basin, being off to the side. This makes shaving or other acts of grooming ungainly for all occupants.

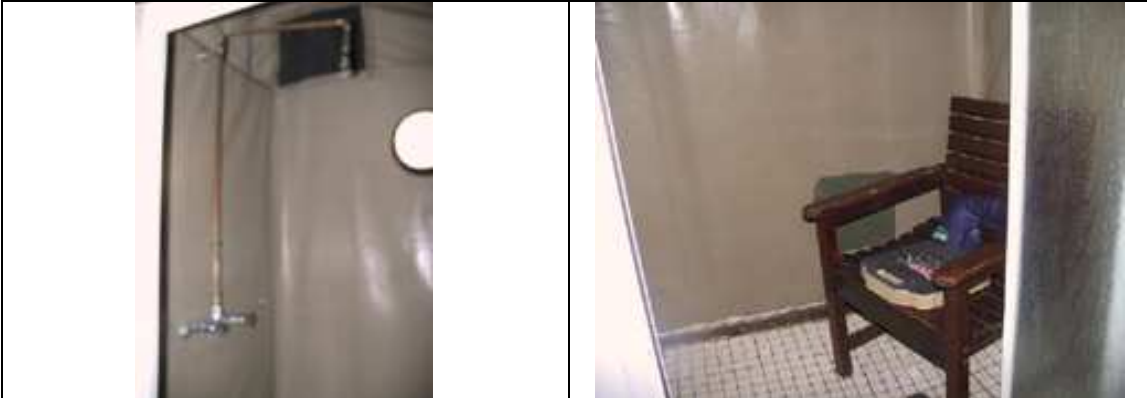
But the biggest problem with the unit's ablutions from an access perspective is with the roll-in shower. There is no step or curb into the shower cubicle, but there is no detachable handset on a height adjustable sliding pole, so a wheelchair user cannot position the spout at an appropriate position, nor remove the handset to properly wash the immobile parts of their body. There is no push style mixer for people with limited grasping ability to turn the flow on and off. Then there is no fixed fold down seat for transfer out of one's wheelchair when showering. I got round this failing by dragging one of the chairs from the deck into the shower, but this is far from ideal and the camp management needs to address these situations urgently. If the dry walls of the shower are not strong enough to support a shower seat and a person sitting on it then mobile shower seats should be provided.
