Pretoriuskop Rest Camp, Kruger National Park – Access for Guests with Mobility Challenges

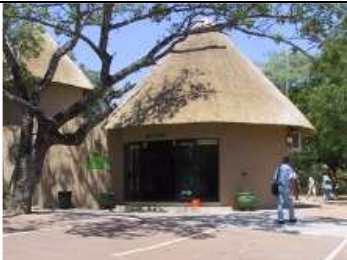
The camp's reception has a handful of demarked bays, one of which is marked for wheelchair use. Entrance to reception is up steps, but there is an alternative entrance with no steps that guests in wheelchairs can use. There are public toilets including an accessible one round the back of the reception block

The reception's accessible ablution facility is useable, but the basin is a little far from the toilet, which is rather low and the adjacent grab rail is fixed at an angle.

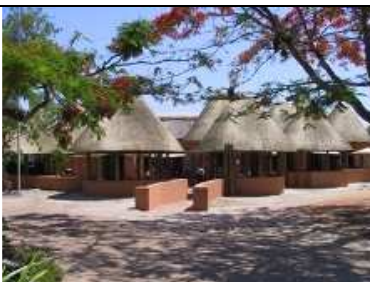
The camp's cafeteria and restaurant have good access and while there is a small section of the indoor portion of the restaurant that is up steps (where the bar is located), the rest of the facility can be used with ease and comfort. The camp shop is fully accessible with ramped access and wide aisles inside.

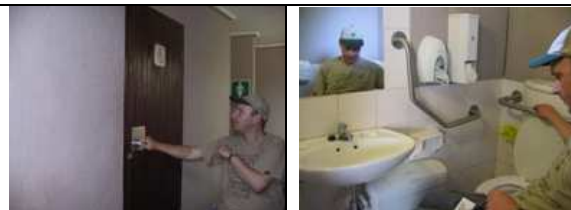
There are suitable accessible ablutions between the restaurant and the shop complex. The grab rails are correctly position and the basin is within reach of a person seated on the toilet.

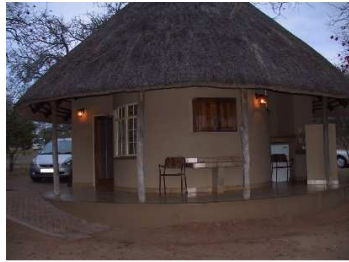
Bungalows 115 and 116 (which are essentially identical) were converted to be accessible to guests with mobility difficulties over 20 years ago, and while some minor improvements have been made to the units, their basic layout has remained the same. They provide comfortable access and have an excellent location on the perimeter fence near the swimming pool complex. They are however quite far from the restaurant, shop and reception and the route in between is sloped, so some people may prefer to drive.

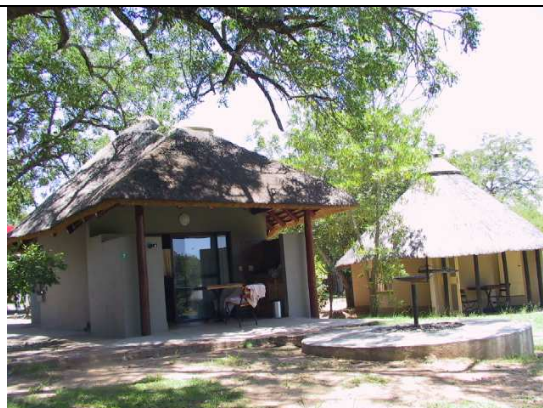
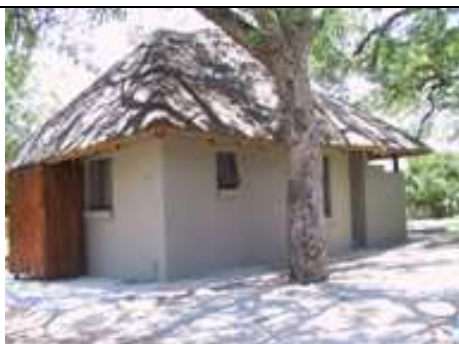
The newest accessible unit in Pretoriuskop is a 2-bed bungalow (**unit number 3** with the code BD2MZ). This unit was refurbished and converted into an accessible unit during 2009 and has a comfortable finish. It is located in the circle of bungalows adjacent the petrol pump and is convenient to the restaurant and reception area.

The unit's parking is on a slight slope and a large tree provides welcome shade, but means that one has to park at an angle to ensure there is sufficient space for a wheelchair to disembark and still be able to get around the vehicle to access the unit.

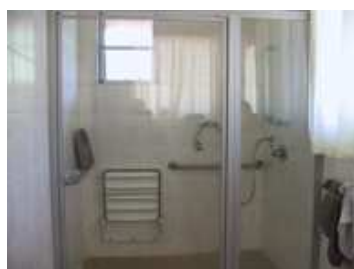
The unit's ablutions are a mixture of good and in need of some alterations. The toilet and basin set up is excellent, with the basin fitted with push taps and within reaching distance of the toilet which has grab rails positioned appropriately. The mirror is also well positioned. One maintenance problem that needs to be monitored is the securing of the toilet seat to its bracket.

The unit's roll-in shower is spacious and has all the components that are required. It is actually a dual shower with one shower head on the ceiling akin to a standard shower, and one detachable handset on a height adjustable sliding pole. This would be ideal except that the fold down seat is fitted on the far side of the shower out of reach from the mixer and the shower and the only way for a person who cannot stand can use it is to detach the set and balance it over the end of the grab rail while they then transfer from their wheelchair onto the seat. The seat and grab rails need to be shifted to alternative positions which hopefully will be done in the near future before anyone reading this has the opportunity to use the facility.

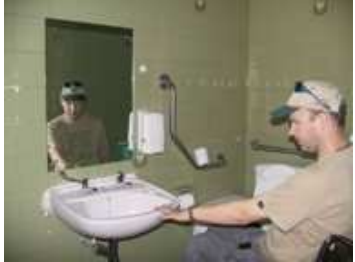
<p>The facility's basin has good clearance, push taps are provided and the mirror is well positioned. The toilet is in a good place for users to access the basin while on the toilet and the grab rails are in the correct position</p>

<p>The facility's shower however is somewhat cramped being a three wall design and the detachable hand shower is of an old and poor design and could be replaced by a better one.</p>
